**Case Study Investigating Elevated Levels of
PCBs in Storm Drain Sediments
in the
Pulgas Creek Pump Station Drainage
San Carlos, California**

**San Mateo Countywide
Stormwater Pollution
Prevention Program**

June 2003

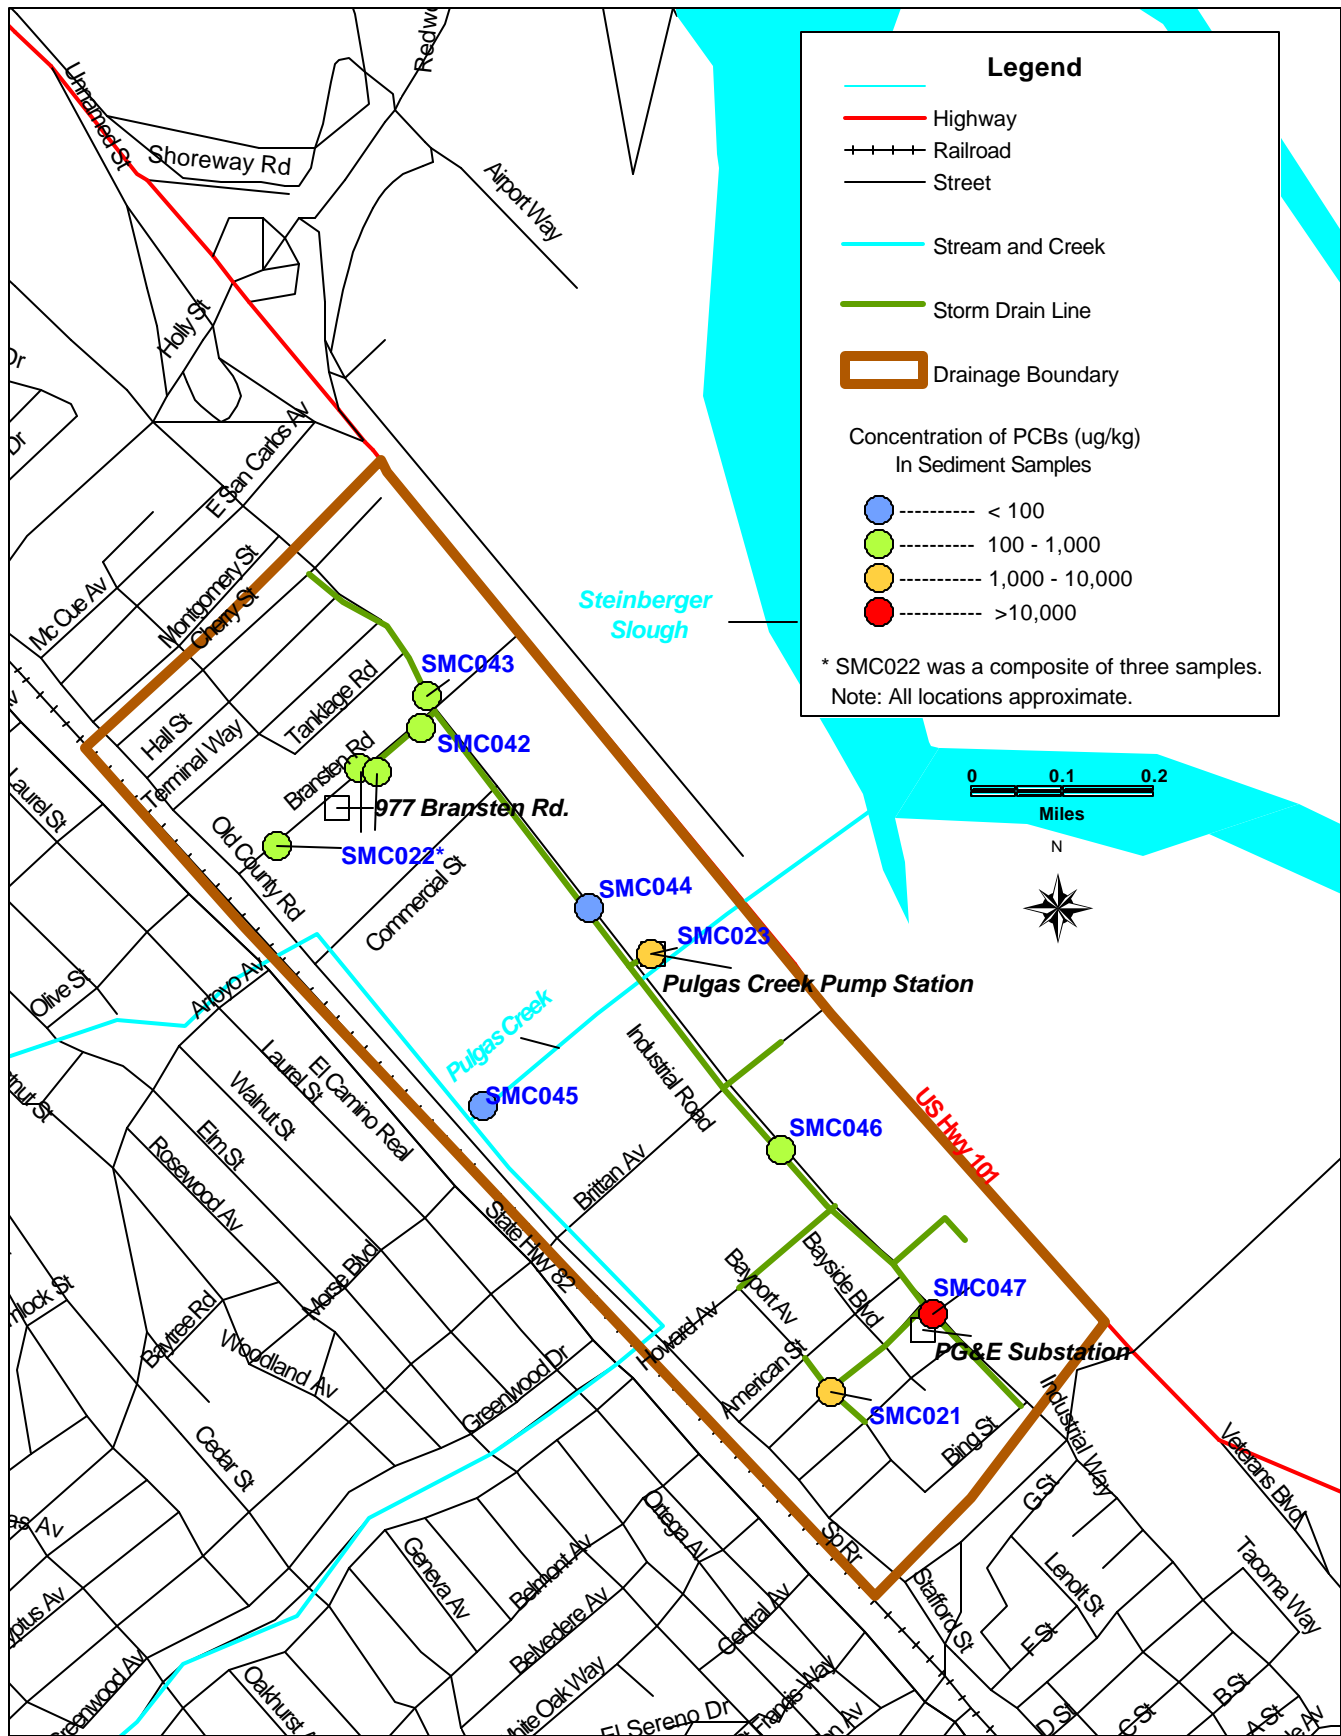
Figure 1
Pulgas Creek Pump Station Drainage

PCBs were detected at concentrations ranging from 3 to 11,521 ug/Kg (Table 1) in samples collected from the following four general areas (Figure 1):

- the Pulgas Creek pump station
- storm drain lines northwest of the pump station
- storm drain lines southeast of the pump station
- Pulgas Creek

The general strategy of the field program was to try to narrow potential source areas by collecting storm drain sediment samples from various locations within the two storm drain line networks feeding the pump station. This included collecting a sample adjacent to a PG&E substation located at Center Street and Industrial Road (Figure 1).

During this study, STOPPP contacted hazardous materials inspection staff with the San Mateo County Environmental Health Department and pretreatment inspection staff with the South Bayside Systems Authority regarding the study area. The inspectors were aware of only one specific site, 977 Bransten Rd., where PCBs were used, stored or released in the study area (Figure 1). STOPPP performed a preliminary review of public records on 977 Bransten Rd. available at the California EPA Department of Toxic Substances Control (DTSC) in Berkeley, California. The site is a soil and groundwater investigation and remediation site located across the street from the City of San Carlos’ corporation yard. A 1989 document refers to the “California Oil Recyclers, Inc. facility at 977 Bransten Road, San Carlos, California” (Aquifer Sciences, Inc., 1989). PCBs were detected at concentrations as high as 67,000 ug/Kg in “near surface soils” (Aquifer Sciences, Inc., 1991 and Conservtech, 1994). STOPPP’s consultant collected storm drain sediment samples SMC-022 and SMC-042 from storm drain inlets and a manhole on Bransten Rd (Figure 1). PCBs were detected at 291 and 306 ug/Kg, respectively (Table 1).

Sample SMC-047 and field replicate SMC-047R were collected from a manhole adjacent to the PG&E substation located at the corner of Industrial Road and Center Street (Figure 1). These samples contained the highest concentrations of PCBs found during this study, suggesting the PCBs in these samples originate from a major source in the drainage. This is corroborated by the similar congener distributions found among SMC-047, SMC-047R and samples collected from the pump station sump (SMC-023), which collects sediment from the entire drainage. However, sample SMC-043, collected in a different part of the drainage (northwest storm drain line branch), also had a similar congener distribution. It should be noted that attempts to link different samples to a single source based on congener distributions may be confounded by factors such as weathering of PCBs in the environment and the possibility of multiple PCBs sources. It should also be noted that SMC-046, the only sample collected between SMC-

¹See Figure 1 for sample locations.

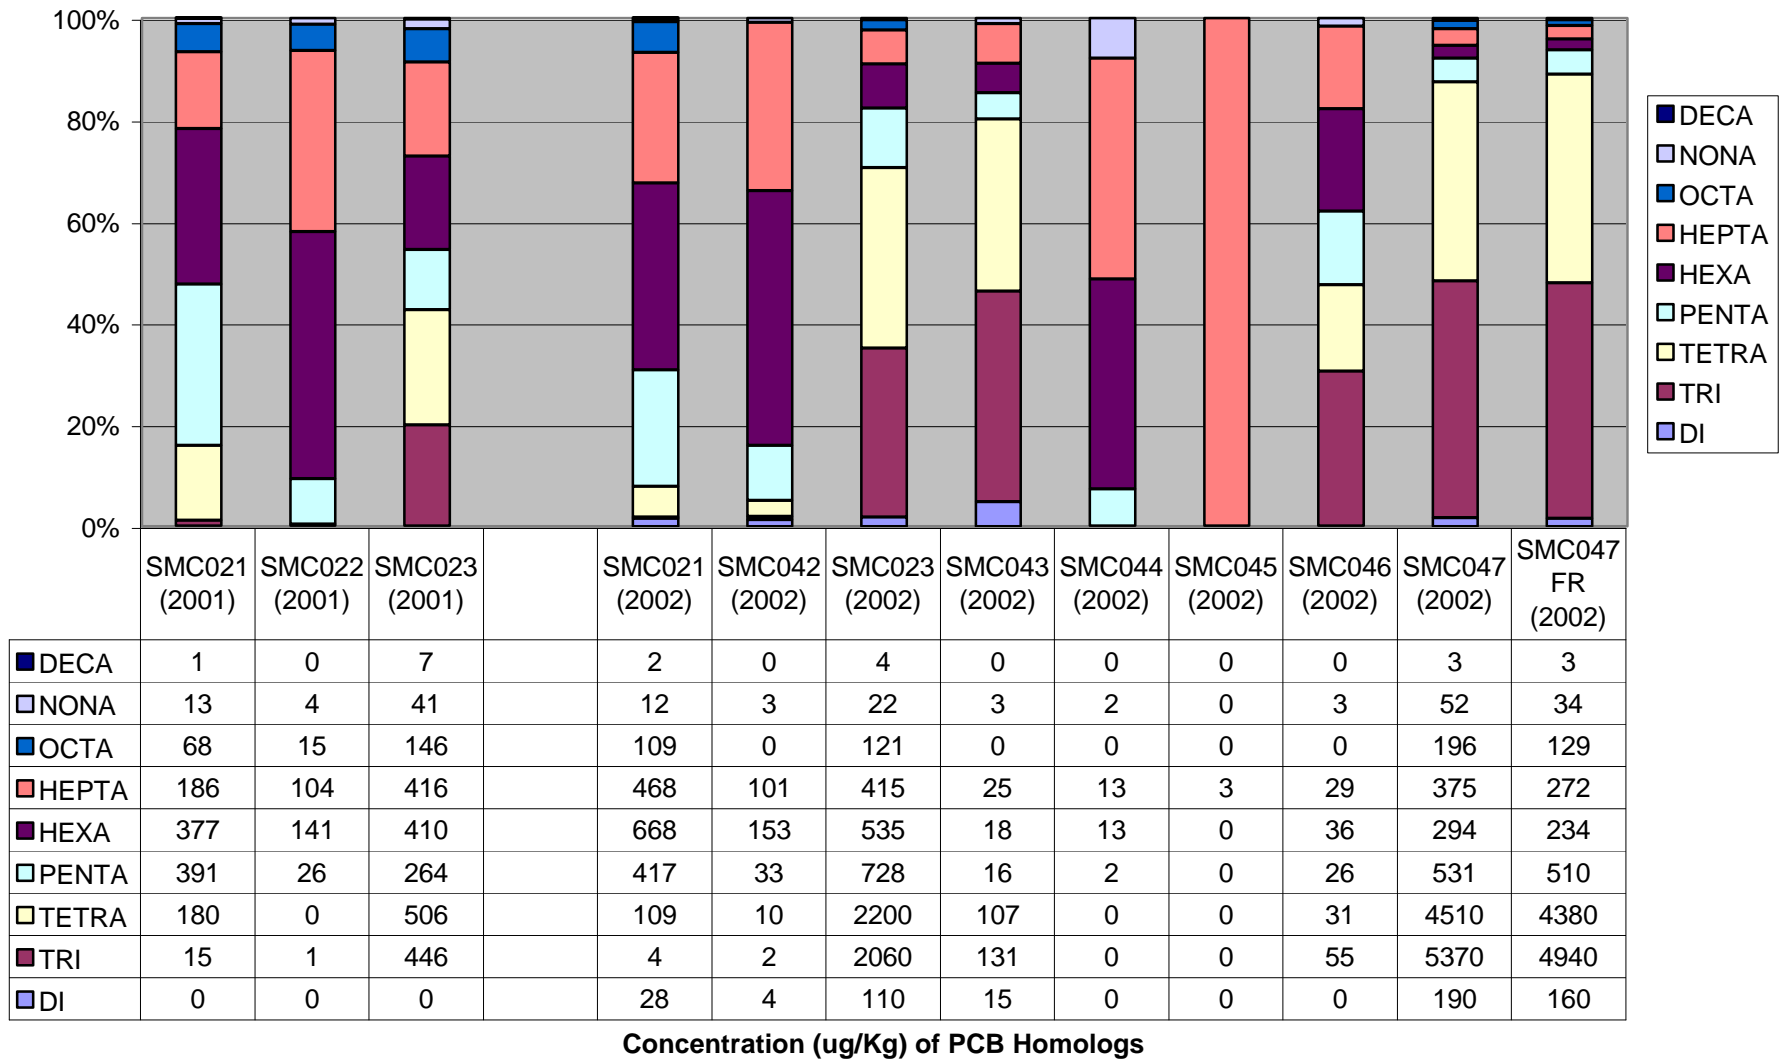
Figure 3 - Distribution of PCB Homologs

The distribution of PCB homologs in each sample are summarized in Figure 3. Sediment trapped in the intake well of the Pulgas Creek Pump Station come from sources throughout the drainage area. When multiple sources of PCBs from different Aroclor formulations exist within the drainage it is often difficult to determine the characteristics of these sources especially with complications introduced by aerobic and anaerobic weathering.

The Appendix, Figure 3 illustrates the distribution of PCB congeners in samples collected to date from the Pulgas Creek pump station drainage. The following samples have a distribution of PCBs congeners that somewhat resembles the distribution in the pump station sump samples (SMC-023) collected during September 2001 and this study (October 2002):
